Fair Oak & Horton Heath Parish Council

SUMMONS

8. PLAY AREA INSPECTIONS (REPORT A, PAGES 3-46)

To consider the recent play area inspections and consider any recommendations arising from the inspection reports.

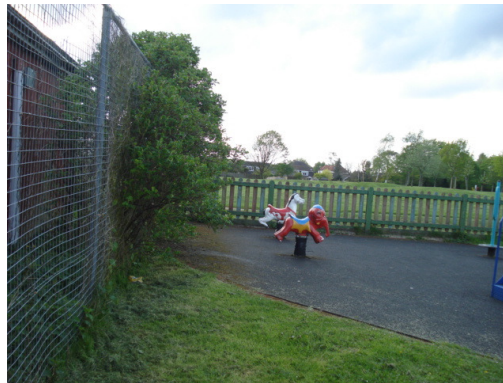
photo 1

Encroaching shrubs from the scout hut premises. *Trim back to the fence line and maintain as such (photo 1).* Medium risk

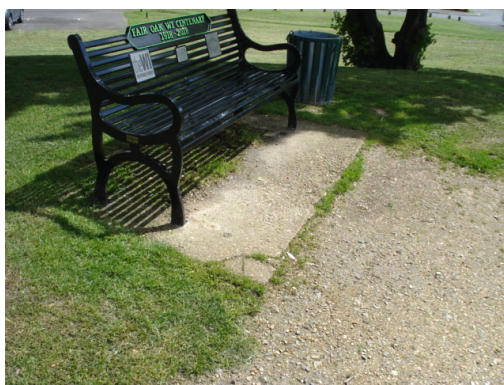
photo 2

- (i) Adjacent to item 10 (Basketball post). Satisfactory.
- (ii) Adjacent to item 13 (Seated Row/Twister) Fair Oak W.I. Centenary seat.
Worn material in the footfall area. *Make up flush to the concrete, if erosion & puddles remain a problem, the provision of slabs or a durable surface to eliminate trip zones is suggested (photo 2).* Medium risk

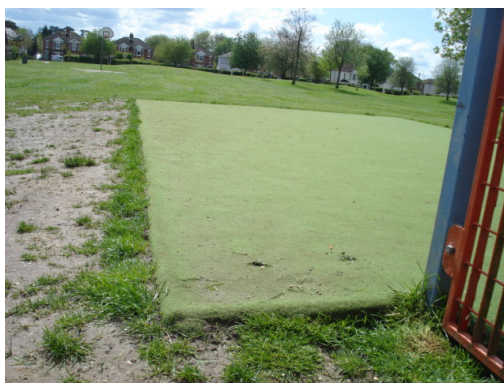
photo 3

Trip zones at the edge with a settled playing surface within the timber Nottsport edgings leaving the edgings proud. *Consider lifting the edges of the Nottsport and either adjusting the level of the edgings flush to the playing surface and abutting soil/grass, maintaining as such, or removing the edgings completely & chasing the carpet edges into the soil/grass avoiding sharp gradients (maximum of 1:5 recommended) (photo 3).* Medium/high risk

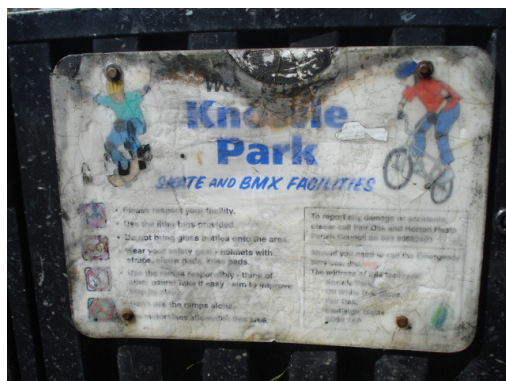
photo 4

Skate users sign attached to the litter bin behind the shelter faded/unclear (photo 4).

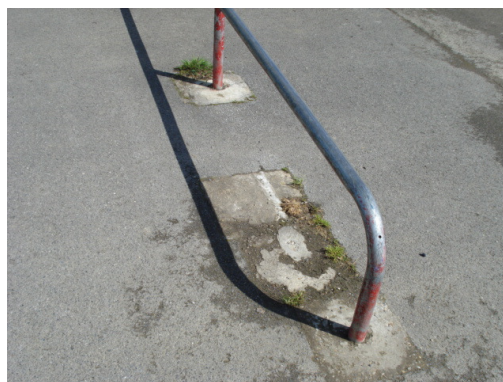
photo 5

Repair uneven concrete/bitmac skate riding surface flush (photo 5). Medium risk

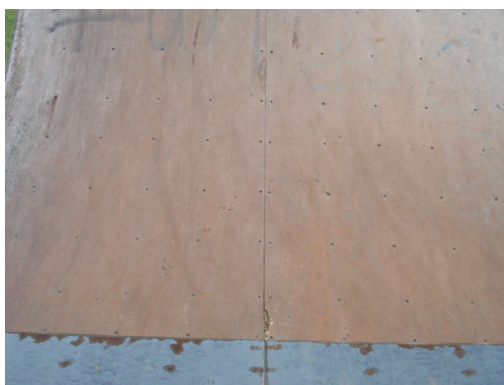
photo 6

Damage/wear to the ramp surface. *Repair flush prior to the school summer holidays recommended (photo 6).*
